**Flood Control Project Maintenance
Levee Inspections**
LMA District Cover Sheet
Spring 2017 Levee Inspection Results

Yolo County Service Area 6

Spring 2017 Levee Inspection Results

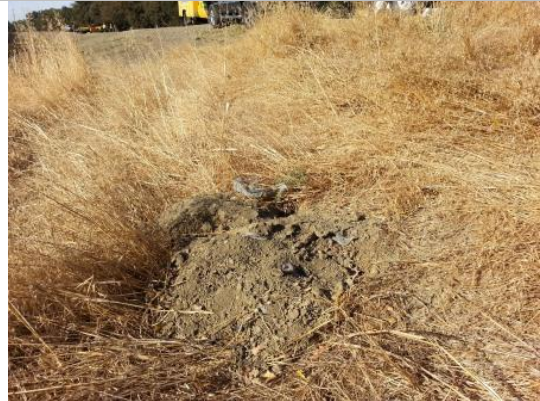
Photo 1 of 1 : SP_2017_NA0022_350_64_20170320_00049.jpg

LM Start	0.01	Rating **	U	Issue No.	64
LM End	0.01	Issue Type +	Ma	Location *	LS
Category	Earthen Levee			GPS Latitude/Longitude	
				Start	End
Item	Animal Control			38.799215 °	38.799215 °
				-121.724341 °	-121.724341 °
DWR ID	DWR_NA0022_01_f _ 2016_64				
Comment Code					
A3 : No rodents visible, but rodent burrows visible; need to backfill and compact or grout burrows.					
Inspector Comment					
More than 2 cub.ft of soil observed around the burrow.

Rodent burrow on LS slope of the levee across from Outfall Gates. Fall inspection 10/07/2016.

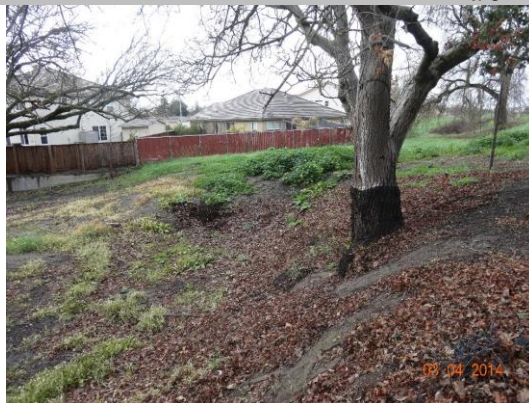
Photo 1 of 3 : UCIP_SP_2017_31903_58222.jpg

Comment Code					
Inspector Comment					
FS_ID:31903					
DS_ID:19515					
EP_NO: 9425					
Repair Type: Non-Urgent					
Crossing Status: Found					
UCIP Comments: Need to properly abandon crossing per Title 23-- pipe has been disconnected. No signs of pipe visible on waterward and landward sides. Need to contact owner to determine additional information about pipe section through levee.					
FIELD_STRUCT_DESC: *ABANDONED* 8-inch steel irrigation pipe through the levee, 3.0-feet below the crown. Pump structure in channel. (Automatic Board Order (ABO) issued as Permit No. 9425, 1974 - Nuttall). [Additional Reference(s): DWR Levee Log, 1990 and 2005].					
FS Date: 3/4/2014

View of landward side.

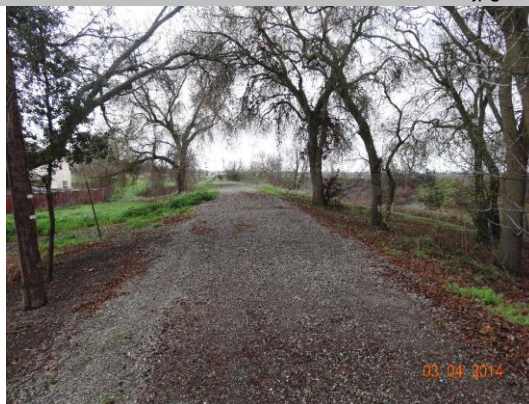
Photo 2 of 3 : UCIP_SP_2017_31903_58221.jpg

Overview of levee crown looking at crossing.

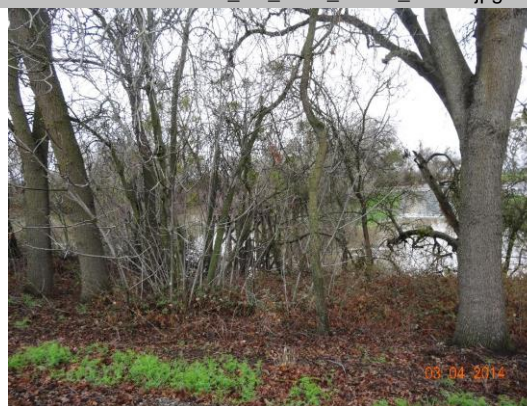
Photo 3 of 3 : UCIP_SP_2017_31903_58220.jpg

Item	DWR UCIP Field Study			38.800647 °		38.800647 °
				-121.723212 °		-121.723212 °
DWR ID						
Comment Code						
Inspector Comment						
FS_ID:31903						
DS_ID:19515						
EP_NO: 9425						
Repair Type: Non-Urgent						
Crossing Status: Found						
UCIP Comments: Need to properly abandon crossing per Title 23-- pipe has been disconnected. No signs of pipe visible on waterward and landward sides. Need to contact owner to determine additional information about pipe section through levee.						
FIELD_STRUCT_DESC: *ABANDONED* 8-inch steel irrigation pipe through the levee, 3.0-feet below the crown. Pump structure in channel. (Automatic Board Order (ABO) issued as Permit No. 9425, 1974 - Nuttall). [Additional Reference(s): DWR Levee Log, 1990 and 2005].						
FS Date: 3/4/2014

View of waterward side.

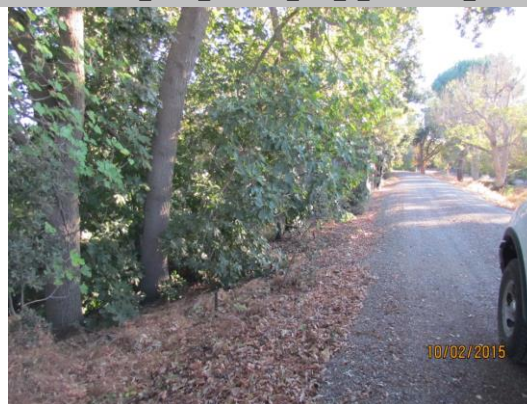
Photo 1 of 1 : SP_2017_NA0022_350_6_20170320_00007.jpg

LM Start	0.13	Rating **	M	Issue No.	6
LM End	0.20	Issue Type +	Ma	Location *	WS
Category	Earthen Levee			GPS Latitude/Longitude	
				Start	End
Item	Trim / Thin Trees			38.800645 °	38.801336 °
				-121.723172 °	-121.722106 °
DWR ID	DWR_NA0022_01_s_2012_6				
Comment Code					
T3 : Trim and thin trees to allow visibility of the ground and room to flood fight.					
Inspector Comment					
Trim trees to allow visibility.

View of the vegetation and trees on the waterward side of the levee looking downstream. Fall 2015.

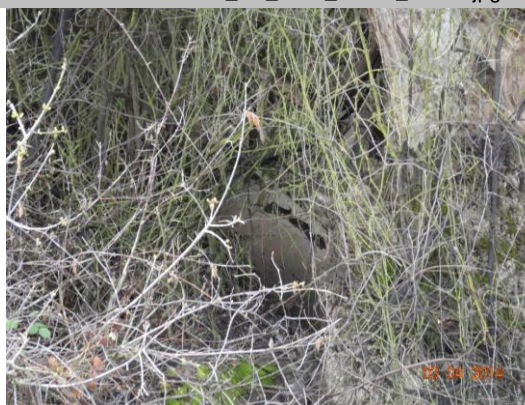
Photo 1 of 3 : UCIP_SP_2017_31904_58228.jpg

LM Start	0.21	Rating **	M	Issue No.	397
LM End	0.21	Issue Type +	En	Location *	LS
Category	Supplemental			GPS Latitude/Longitude	
				Start	End
Item	DWR UCIP Field Study			38.801280 °	38.801280 °
				-121.722000 °	-121.722000 °
DWR ID					
Comment Code					
Inspector Comment					
FS_ID:31904 DS_ID:19516 EP_NO: N/A Repair Type: Non-Urgent Crossing Status: Indicator Found UCIP Comments: Need to properly abandon per Title 23 if corssing is no longer used--debris inside concrete box and near site. Need to contact owner. FIELD_STRUCT_DESC: 48-inch corrugated metal pipe through the levee, 14.5 feet below the crown. Slide gate in concrete box on the waterside (WS) bank. (Automatic Board Order (ABO) issued as Permit No. unknown, 1976 - Wallace) [Additional Reference(s): DWR Levee Log, 1990 and 2005] FS Date: 3/4/2014

Pipe section with holes abandoned on waterward side.

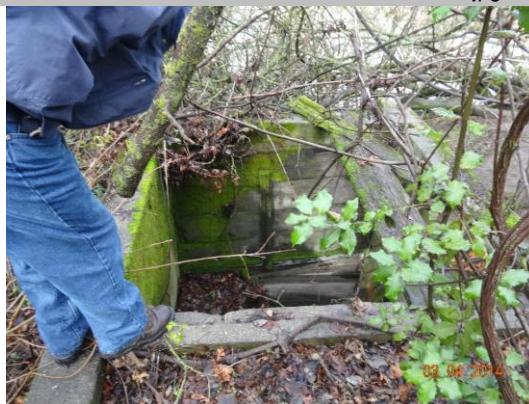
Photo 3 of 3 : UCIP_SP_2017_31904_58226.jpg

LM Start	0.21	Rating **	M	Issue No.	397 (cont)	
LM End	0.21	Issue Type +	En	Location *	LS	
Category	Supplemental			GPS Latitude/Longitude		
				Start		End
Item	DWR UCIP Field Study			38.801280 °		38.801280 °
				-121.722000 °		-121.722000 °
DWR ID						
Comment Code						
Inspector Comment						
FS_ID:31904 DS_ID:19516 EP_NO: N/A Repair Type: Non-Urgent Crossing Status: Indicator Found UCIP Comments: Need to properly abandon per Title 23 if corssing is no longer used--debris inside concrete box and near site. Need to contact owner. FIELD_STRUCT_DESC: 48-inch corrugated metal pipe through the levee, 14.5 feet below the crown. Slide gate in concrete box on the waterside (WS) bank. (Automatic Board Order (ABO) issued as Permit No. unknown, 1976 - Wallace) [Additional Reference(s): DWR Levee Log, 1990 and 2005] FS Date: 3/4/2014

Concrete box located on waterward side.

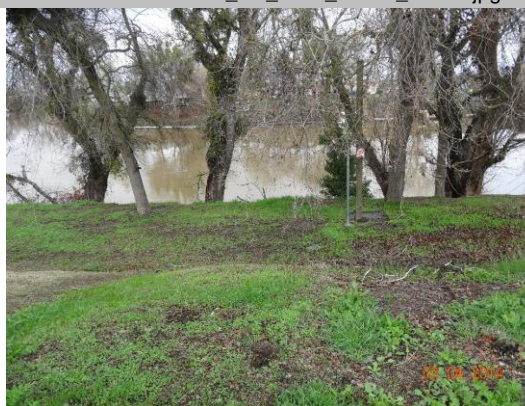
Photo 3 of 3 : UCIP_SP_2017_45403_60803.jpg

Item	DWR UCIP Field Study			38.801597 °		38.801597 °
				-121.721226 °		-121.721226 °
DWR ID						
Comment Code						
Inspector Comment						
FS_ID:45403 DS_ID:19513 EP_NO: 9424 Repair Type: Non-Urgent Crossing Status: Indicator Found UCIP Comments: Unable to determine alignment of crossing--it's either through levee or along landward side. It appears that the waterline goes along landward side. Need to contact owner to obtain additional information about crossing. 2 inch metal pipe sticking out at the waterward berm edge. FIELD_STRUCT_DESC: Water pipe through the levee at an unknown depth below the crown. Faucets in the landside (LS) slope. (Automatic Board Order (ABO) issued as Permit No. 9424, 1974 - Ivey). [Additional Reference(s): DWR Levee Log, 1990 and 2005]. FS Date: 3/4/2014

View of waterward side.

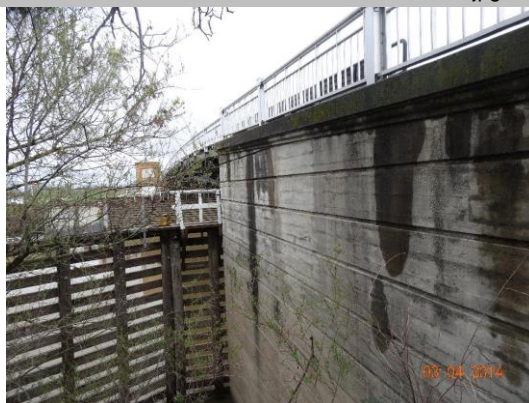
Photo 2 of 2 : UCIP_SP_2017_31906_58237.jpg

FS_ID:31906
DS_ID:19534
EP_NO: 17016
Repair Type: Non-Urgent
Crossing Status: Indicator Found
UCIP Comments: Unable to confirm crossing alignment--steel pipe visible on waterward side however, unable to confirm if crossing is the same one found during field confirmation. Need to contact owner to verify alignment and status of crossing. Slope was too steep to verify and obtain additional information about pipe.
FIELD_STRUCT_DESC: Three 2-inch and three 1.5-inch fiber optic conduits through the levee, encased in a single high-density polyethylene (HDPE) conduit, 30-feet below the levee crown. Concrete caps on both ends of the casing, on the landside (LS) and waterside (WS). Voids in the HDPE conduit grouted. (Permit No. 17016, 2000 - Pacific Fiber Link, LLC).
FS Date: 3/4/2014

No pipe attached along bridge.

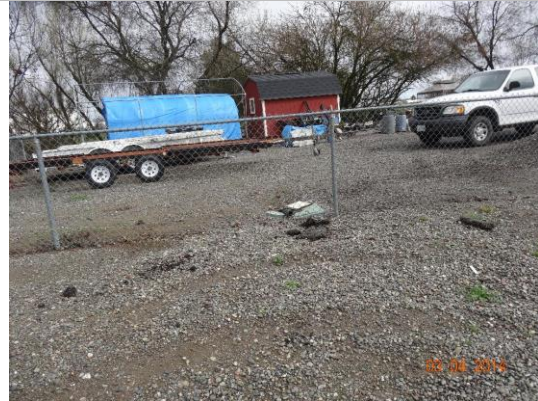
Photo 3 of 3 : UCIP_SP_2017_31627_57879.jpg

Comment Code					
Inspector Comment					
FS_ID:31627					
DS_ID:19544					
EP_NO: N/A					
Repair Type: Non-Urgent					
Crossing Status: Indicator Found					
UCIP Comments: Unable to confirm if signs of crossing are for the same crossing listed here. Need to contact owner and determine additional information about crossing. Also found is service box for water line--need permit and alignment confirmation.					
FIELD_STRUCT_DESC: 10-inch steel pipe through the levee at an unknown depth below the crown. [Additional Reference(s): DWR Levee Log, 1990 and 2005. USACE Sacramento O&M Manual Unit No. 127, June 1953, (Station 285+27)].					
FS Date: 3/4/2014

Service box located on waterward side near fence post.

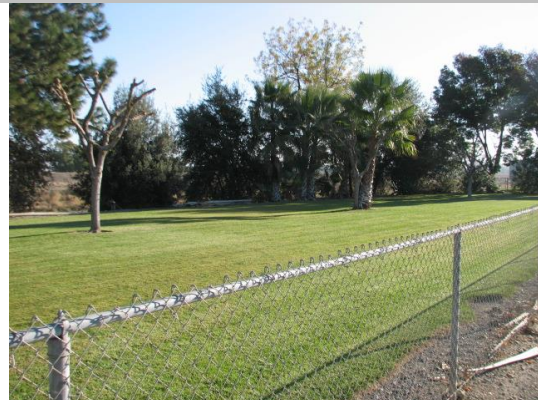
Photo 1 of 1 : SP_2017_NA0022_350_24_20170320_00023.jpg

LM Start	0.54	Rating **	M	Issue No.	24
LM End	0.57	Issue Type +	En	Location *	WS
Category	Earthen Levee			GPS Latitude/Longitude	
				Start	End
Item	Vegetation			38.801910 °	38.801823 °
				-121.716170 °	-121.715683 °
DWR ID	DWR_NA0022_01_s_2012_24				
Comment Code					
V6 : Landscaping					
Inspector Comment

The lawn area is on the levee waterside and crown. Fall 2013

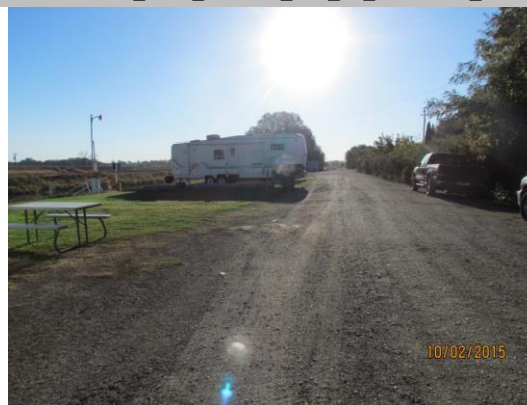
Photo 1 of 1 : SP_2017_NA0022_350_23_20170320_00022.jpg

View of the Yacht club on the crown of the levee looking downstream.
Fall 2015.

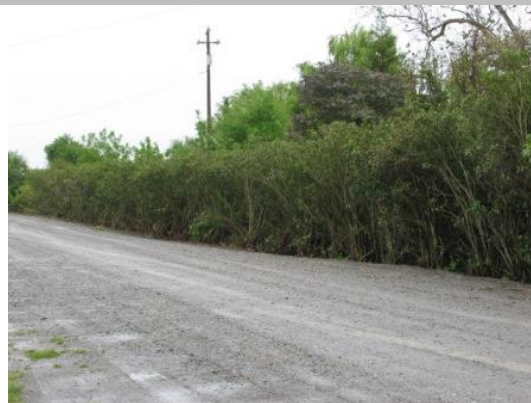
Photo 1 of 1 : SP_2017_NA0022_350_22_20170320_00021.jpg

Oleanders along the shoulder.

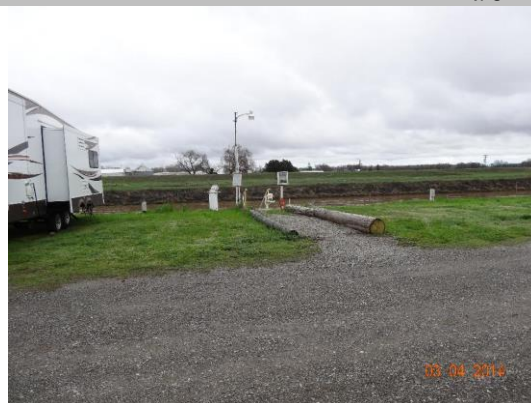
Photo 1 of 3 : UCIP_SP_2017_38188_69562.jpg

LM Start	0.57	Rating **	M	Issue No.	402
LM End	0.57	Issue Type +	En	Location *	LS
Category	Supplemental			GPS Latitude/Longitude	
				Start	End
Item	DWR UCIP Field Study			38.801798 °	38.801798 °
				-121.715584 °	-121.715584 °
DWR ID					
Comment Code					
Inspector Comment					
FS_ID:38188 DS_ID:19519 EP_NO: N/A Repair Type: Non-Urgent Crossing Status: Indicator Found UCIP Comments: Unable to find any signs of crossing on waterward side. Signs of concrete riser visible on landward side. If crossing is abandoned owner will need to coordinate with the Central Valley Flood Protection Board (CVFPB) for Title 23 requirements. FIELD_STRUCT_DESC: 10-inch pipe of unknown material through the levee, 3.3 feet below the crown. Plate welded on waterside (WS) end in 1975. 24-inch concrete riser on the landside (LS). [Additional Reference(s): DWR Levee Log, 1990 and 2005]. FS Date: 3/4/2014

View of waterward side.

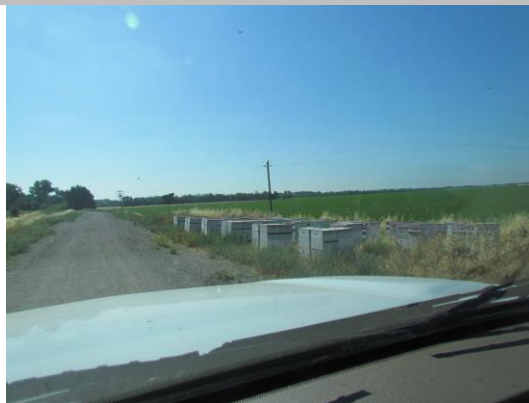
Photo 1 of 1 : SP_2017_NA0022_350_73_20170320_00056.jpg

View of the beehives on the landward side of the levee looking downstream. Spring 2015.

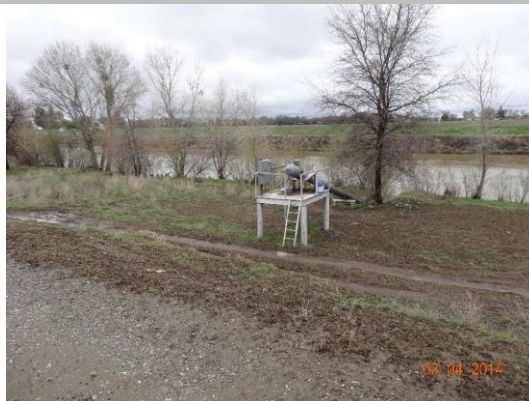
Photo 1 of 3 : UCIP_SP_2017_31969_58410.jpg

LM Start	0.93	Rating **	M	Issue No.	403
LM End	0.93	Issue Type +	En	Location *	LS
Category	Supplemental			GPS Latitude/Longitude	
				Start	End
Item	DWR UCIP Field Study			38.800200 °	38.800200 °
				-121.709258 °	-121.709258 °
DWR ID					
Comment Code					
Inspector Comment					
FS_ID:31969 DS_ID:19540 EP_NO: N/A Repair Type: Non-Urgent Crossing Status: Found UCIP Comments: Pipe section on waterward side appears to have been removed and reinstalled--Need to contact owner to obtain additional information regarding work completed. FIELD_STRUCT_DESC: 14-inch steel irrigation pipe through the levee, 4.6 feet below the crown. Pump and valve are located on the waterside (WS) bank. Pipe and pump were removed and replaced under Permit No. 3798 (1962) SEE DS_ID 19521. [Additional Reference(s): USACE Sacramento O&M Manual Unit No. 127, June 1953, (Station 266+72.2)]. FS Date: 3/4/2014

View of waterward side.

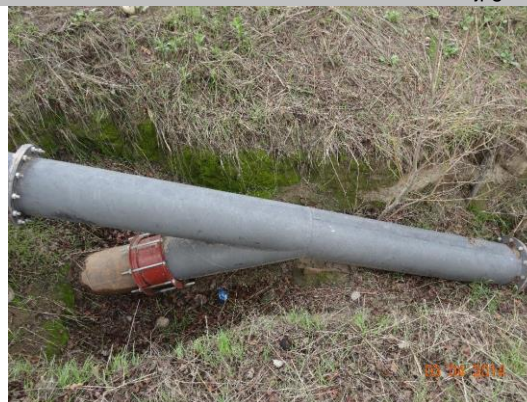
Photo 3 of 3 : UCIP_SP_2017_31969_58408.jpg

Item	DWR UCIP Field Study			38.800200 °		38.800200 °
				-121.709258 °		-121.709258 °
DWR ID						
Comment Code						
Inspector Comment						
FS_ID:31969						
DS_ID:19540						
EP_NO: N/A						
Repair Type: Non-Urgent						
Crossing Status: Found						
UCIP Comments: Pipe section on waterward side appears to have been removed and reinstalled--Need to contact owner to obtain additional information regarding work completed.						
FIELD_STRUCT_DESC: 14-inch steel irrigation pipe through the levee, 4.6 feet below the crown. Pump and valve are located on the waterside (WS) bank. Pipe and pump were removed and replaced under Permit No. 3798 (1962) SEE DS_ID 19521. [Additional Reference(s): USACE Sacramento O&M Manual Unit No. 127, June 1953, (Station 266+72.2)].						
FS Date: 3/4/2014

Pipe junction exposed on waterward side.

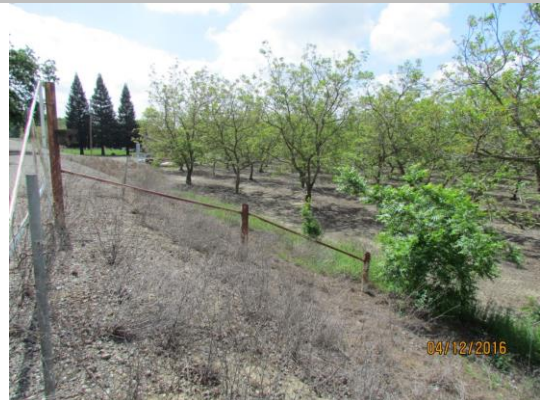
Photo 1 of 1 : SP_2017_NA0022_350_112_20170320_00087.jpg

View of the tree at the toe of the levee on the landward side looking downstream. Spring 2016.

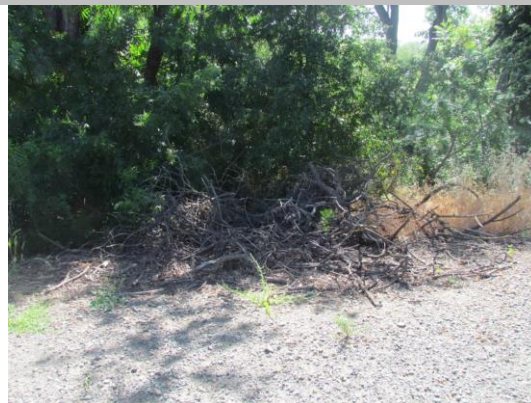
Photo 1 of 1 : SP_2017_NA0022_350_44_20170320_00042.jpg

View of the prunings on the waterward side of the levee. Spring 2015.

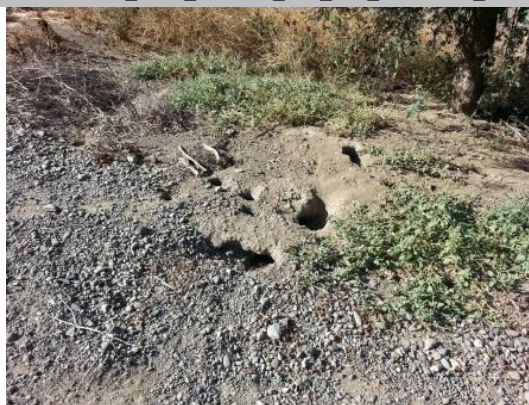
Photo 1 of 1 : SP_2017_NA0022_350_117_20170320_00090.jpg

Series of animal burrows on LS slope of the levee. Fall inspection 10/07/2016.

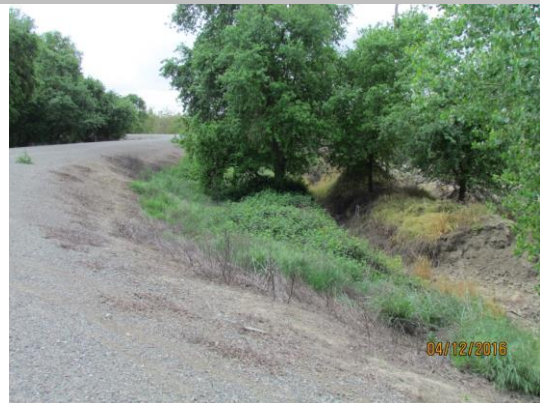
Photo 1 of 1 : SP_2017_NA0022_350_7_20170320_00008.jpg

View of the ditch at the levee toe on the landward side looking downstream. Spring 2016.

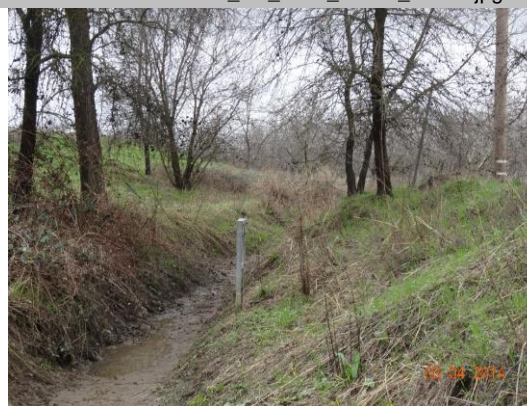
Photo 1 of 3 : UCIP_SP_2017_31915_58270.jpg

Slide gate inside canal.

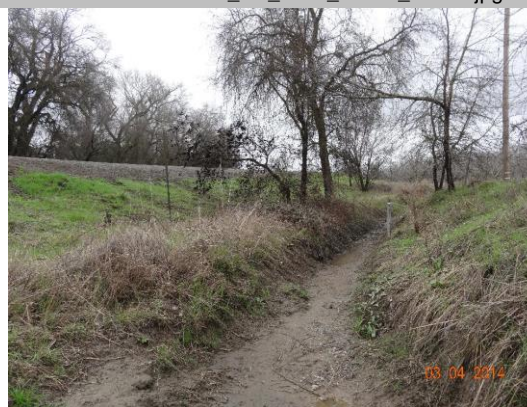
Photo 2 of 3 : UCIP_SP_2017_31915_58269.jpg

View of canal runs parallel on landward toe.

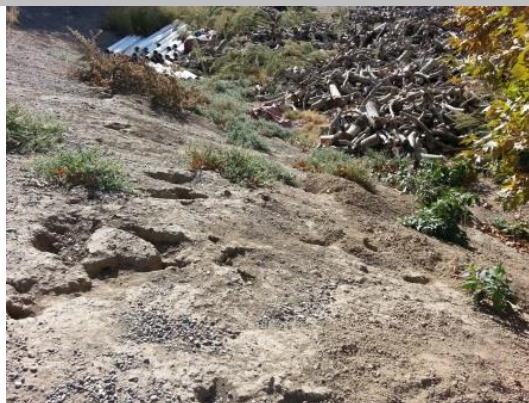
Photo 2 of 3 : SP_2017_NA0022_350_8_20170320_00010.jpg

Another view of the burrows from levee crown. Fall inspection 10/07/2016.

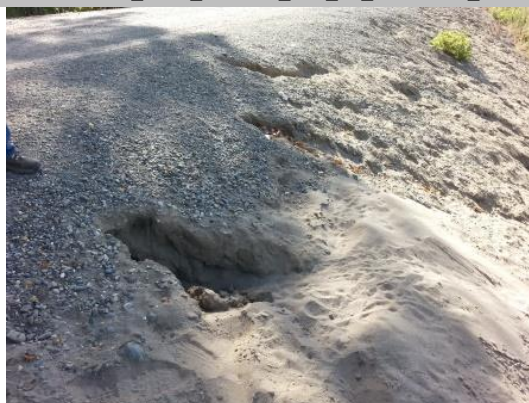
Photo 1 of 2 : SP_2017_NA0022_350_93_20170320_00073.jpg

Slope stability issue in LS slope of the levee. Fall inspection 10/07/2016.

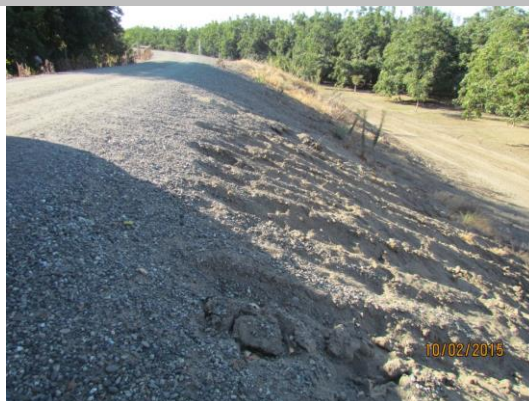
Photo 2 of 2 : SP_2017_NA0022_350_93_20170320_00074.jpg

View of the slope stability on the landward side of the levee looking downstream. Fall 2015.

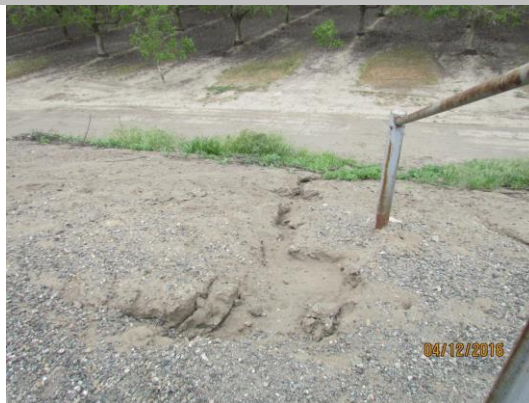
Photo 1 of 2 : SP_2017_NA0022_350_35_20170320_00032.jpg

Erosion is on the landward side of the levee. Spring 2016.

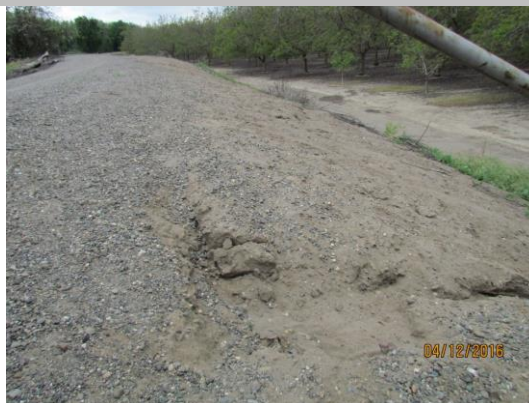
Photo 2 of 2 : SP_2017_NA0022_350_35_20170320_00033.jpg

Perspective view of the erosion on the landward side of the levee. Spring 2016.

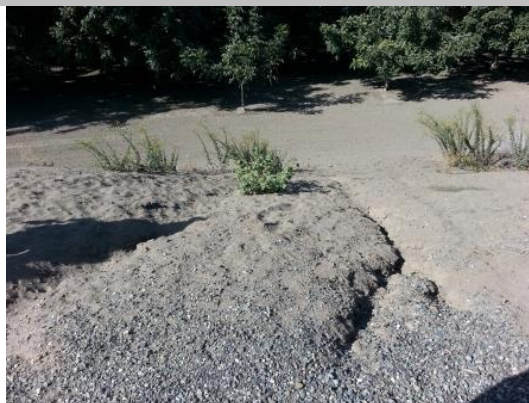
Photo 1 of 1 : SP_2017_NA0022_350_75_20170320_00057.jpg

View of erosion site on landward slope of the levee. Fall inspection 10/07/2016.

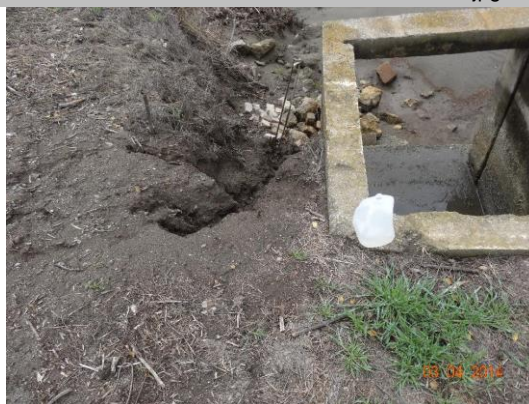
Photo 2 of 3 : UCIP_SP_2017_49982_57914.jpg

Slope erosion near concrete box.

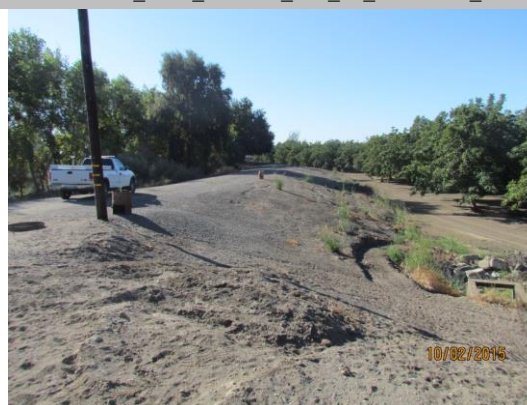
Photo 1 of 3 : SP_2017_NA0022_350_96_20170320_00077.jpg

Perspective view of the erosion around the pipe on the landward side of the levee looking downstream. Fall 2015.

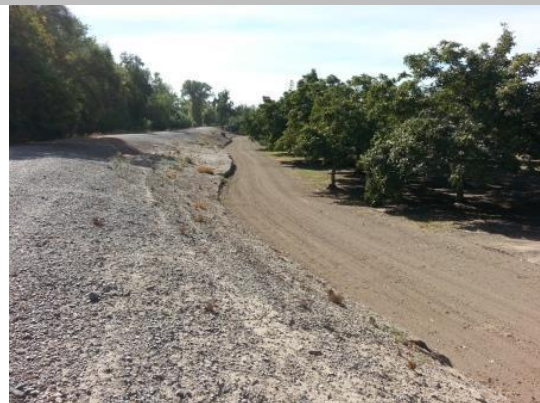
Photo 1 of 2 : SP_2017_NA0022_350_94_20170320_00075.jpg

An updated view of the site where landside slope was tilled due to agricultural activity. Fall inspection 10/07/2016.

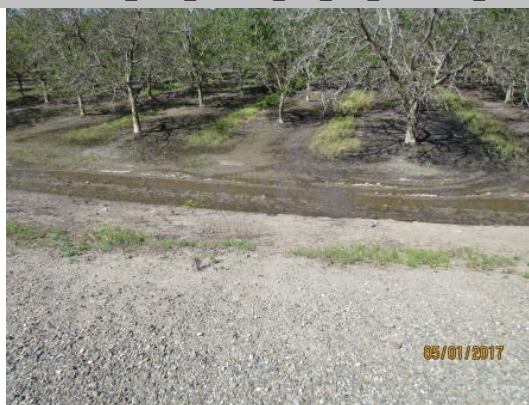
Photo 1 of 1 : SP_2017_NA0022_350_125_20170501_00167.jpg

View of seepage at landside levee toe. Spring 2017.

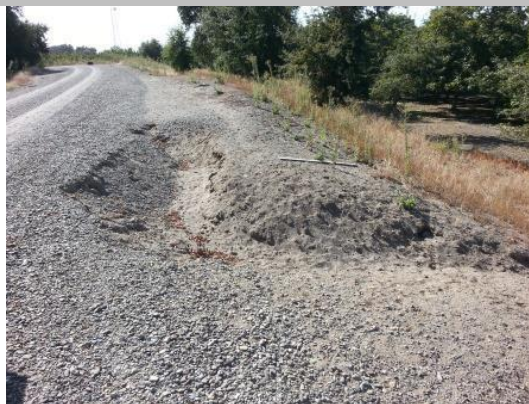
Photo 1 of 2 : SP_2017_NA0022_350_87_20170320_00069.jpg

An updated view of erosion site on LS slope. Fall inspection 10/07/2016.

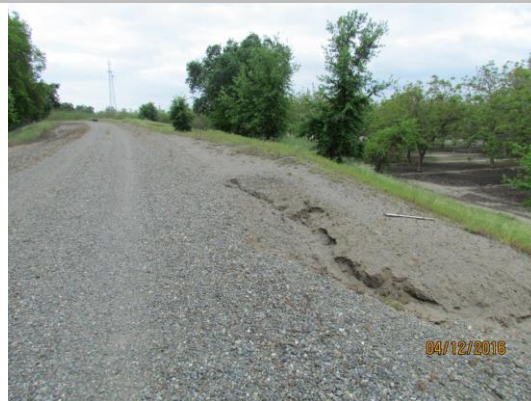
Photo 2 of 2 : SP_2017_NA0022_350_87_20170320_00070.jpg

View of the erosion on the landward side of the levee looking downstream. Spring 2016.

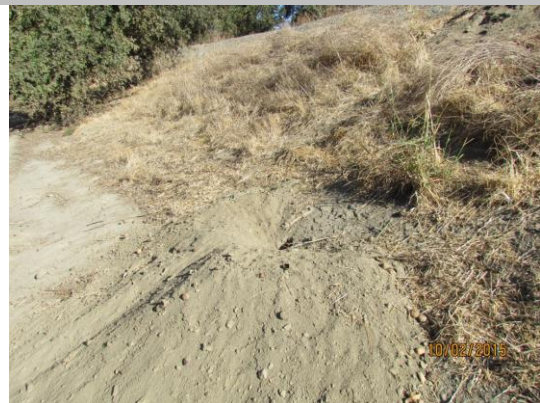
Photo 1 of 2 : SP_2017_NA0022_350_52_20170320_00047.jpg

View of the rodent hole and material on the landward side of the levee.
Fall 2015.

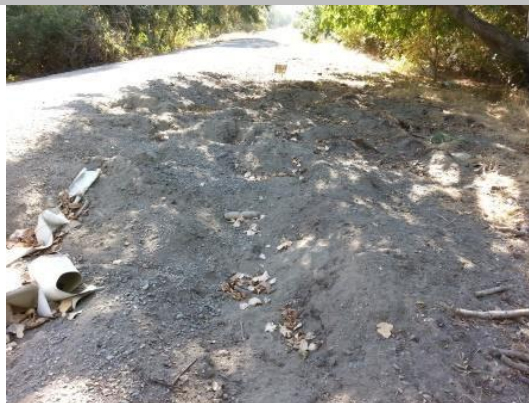
Photo 1 of 1 : SP_2017_NA0022_350_115_20170320_00088.jpg

Slope stability problem site on LS slope likely due to nearby owner's activity. Fall inspection 10/07/2016.

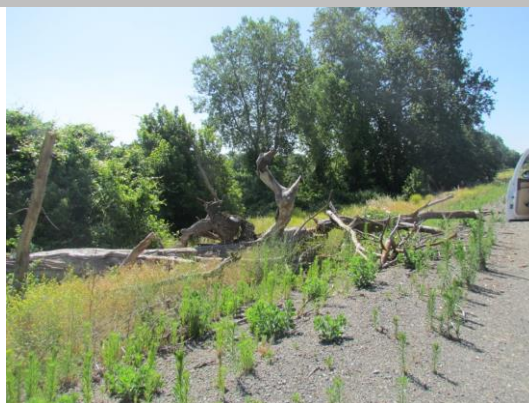
Photo 2 of 2 : SP_2017_NA0022_350_47_20170320_00046.jpg

View of the fallen tree on the waterward side of the levee looking downstream. Spring 2015.

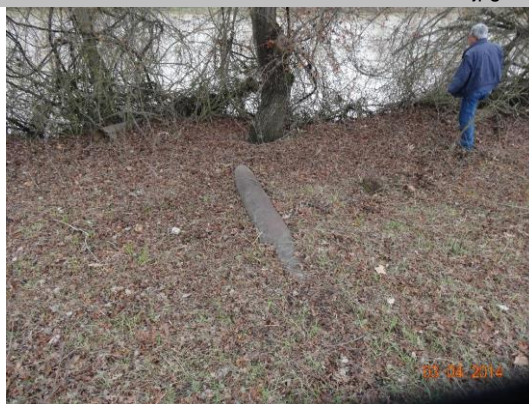
Photo 3 of 3 : UCIP_SP_2017_39858_71845.jpg

Pipe section visible on waterward side.

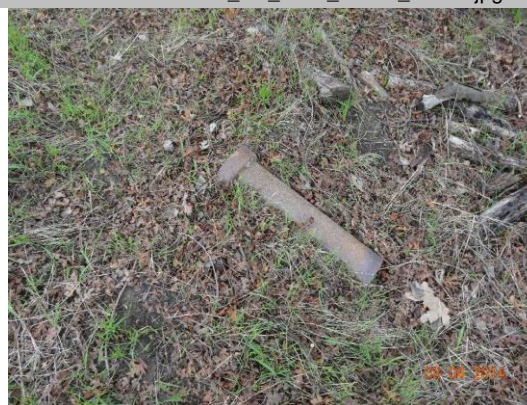
Photo 2 of 3 : UCIP_SP_2017_38996_69567.jpg

Debris scattered on landward side.

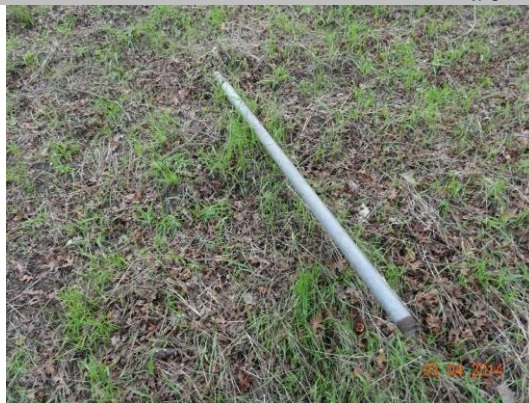
Photo 3 of 3 : UCIP_SP_2017_38996_69566.jpg

Abandoned conduit line through levee.

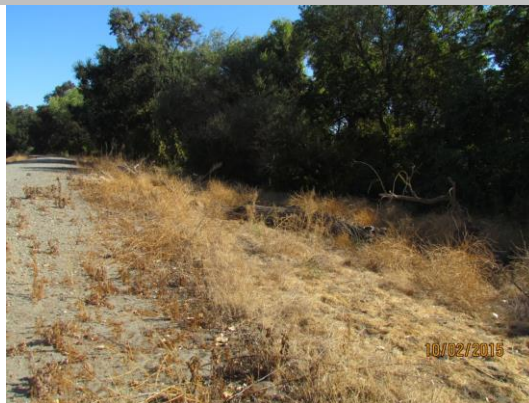
Photo 1 of 1 : SP_2017_NA0022_350_89_20170320_00071.jpg

View of the fallen tree on the waterward side of the levee looking upstream. Fall 2015.

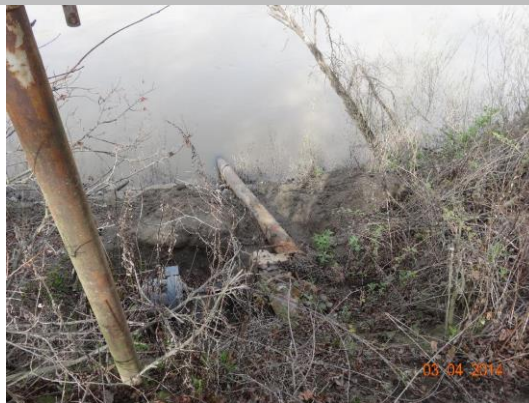
Photo 3 of 3 : UCIP_SP_2017_31927_58335.jpg

Pipe visible on waterward toe.

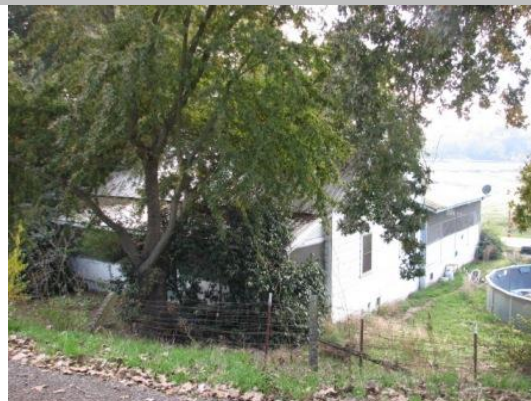
Photo 1 of 1 : SP_2017_NA0022_350_1_20170320_00001.jpg

The house and landscape are in the easement of the levee. Fall 2011

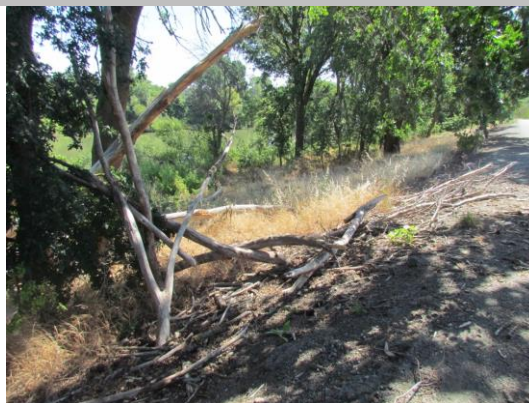
Photo 1 of 1 : SP_2017_NA0022_350_83_20170320_00064.jpg

View of the tree and tree limbs on the waterward side of the levee looking downstream. Spring 2015.

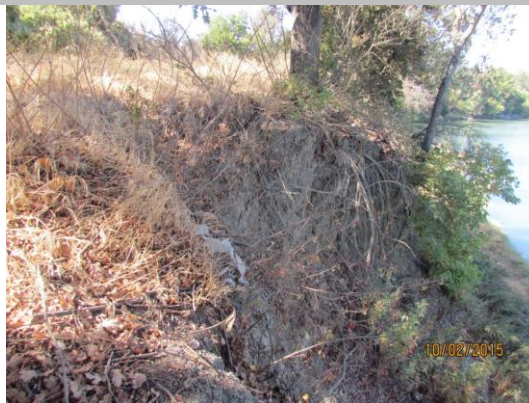
Photo 2 of 3 : SP_2017_NA0022_350_84_20170320_00066.jpg

View of the erosion on the waterward side of the levee looking upstream.
Fall 2015.
